**Flood Control Project Maintenance  
Levee Inspections**

**Fall 2013 Levee Maintenance Deficiency Summary Report**

**Sutter Maintenance Yard Hamilton Bend**

Waterway			Bank	Unit Miles
Unit No. 01 Feather River Hamilton Bend			Right	3.22
	Spring (March - May)	Summer (June - August)	(September - November) Fall	Winter (December - February)
Unit Maintenance Rating (Fall Only)			<b>U</b>	
Date of Inspection	04/23/2013 - 04/23/2013		10/21/2013 - 10/21/2013	
DWR Inspector	Rick Burnett		Matthew Hoffman	
Accompanied By	Jason Cooper Sutter Maintenance Yard		Jason Cooper Sutter Maintenance Yard

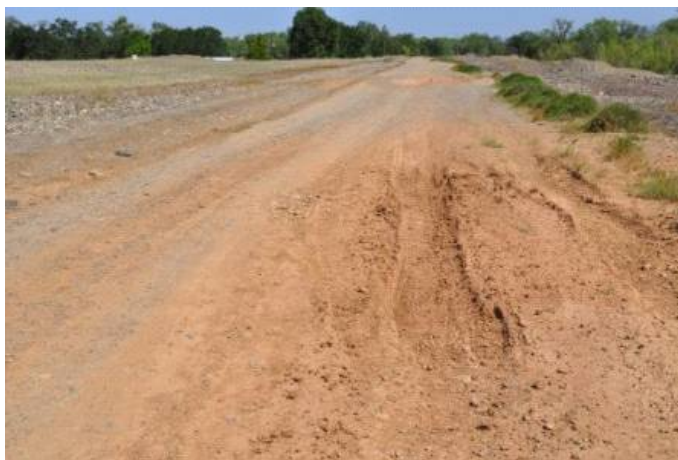
Levee Mile Report Line	4
Start Levee Mile	0.36
End Levee Mile	0.36
Location	Crown
Category	Earthen Levee
Item	Crown Surface / Depressions / Rutting

Deep rut in crown. Repair prior to flood season.

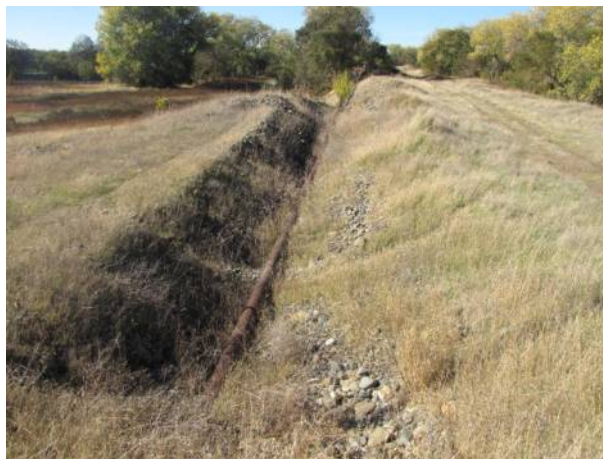
Levee Mile Report Line	6
Start Levee Mile	0.80
End Levee Mile	0.80
Location	Crown
Category	Supplemental
Item	DWR UCIP Field Study

DWR ID: DWR_ST0005_01_f_2013_1											
6	0.80	0.80	Supplemental	DWR UCIP Field Study	CR	M En	Inspector Comments: FS_ID:8363 EP_NO: 927 Repair Type: Non-Urgent Crossing Status: Found UCIP Comments: low spot on WS slope; sink hole or section dug-unable to tell; hole on levee toe. This crossing was listed in the USACE Periodic Inspection as ID# USACE_CESPK_HAM1_2010_a_0029 no issues reported. FIELD_STRUCT_DESC: Abandoned 10-inch steel pipe through the levee 10.4 feet below the crown. (Permit No. 927) FS Date: 11/14/2012	39.451078 ° 39.451078 °	-121.640773 ° -121.640773 °	3 Y	
DWR ID: DWR_ST0005_01_f_2013_3											
7	0.80	0.80	Supplemental	DWR UCIP Field Study	CR	M En	Inspector Comments: FS_ID:7943 EP_NO: 927 Repair Type: Non-Urgent Crossing Status: Found UCIP Comments: low spot on WS slope; sink hole or section dug-unable to tell; hole on levee toe. FIELD_STRUCT_DESC: Abandoned 10-inch steel pipe through the levee 10.4 feet below the crown. (Permit No. 927) FS Date: 11/14/2012	39.451078 ° 39.451078 °	-121.640773 ° -121.640773 °	10

View of ditch and pipe running along landward side.

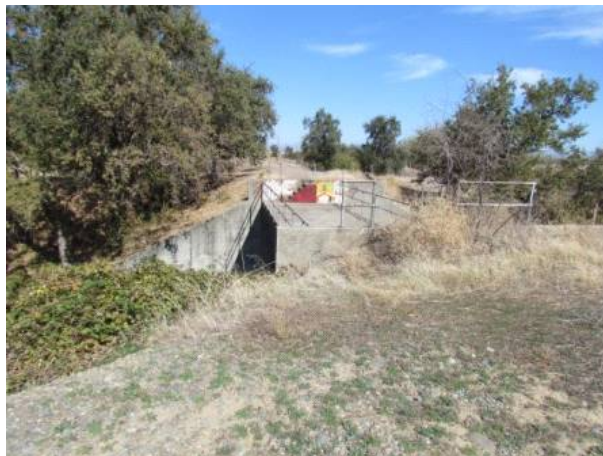
Levee Mile Report Line	9
Start Levee Mile	1.04
End Levee Mile	1.04
Location	Crown
Category	Earthen Levee
Item	Encroachments

9	1.04	1.04	Earthen Levee	Encroachments	CR A/W	En	BU : Building Inspector Comments: Abandoned inlet structure.	39.454464 ° 39.454464 ° -121.640361 ° -121.640361 °	28 Y
---	------	------	------------------	---------------	--------	----	---	--	---------

This photo was taken facing north looking down the levee crown at an old inlet structure. Fall 2013.

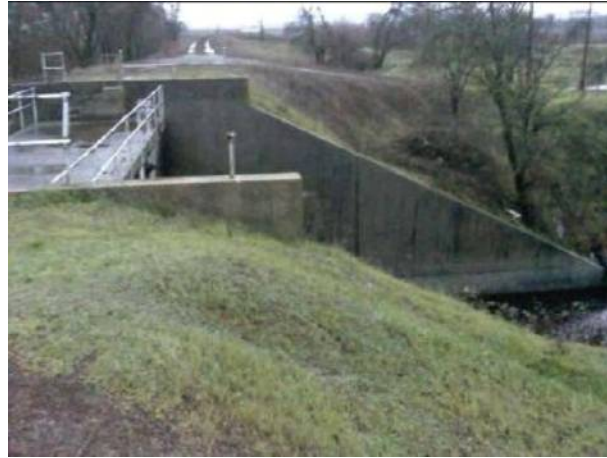
Levee Mile Report Line	11
Start Levee Mile	1.05
End Levee Mile	1.05
Location	Water Side
Category	Supplemental
Item	DWR UCIP Field Study

11	1.05	1.05	Supplemental	DWR UCIP Field Study	CR	M En	Inspector Comments: FS_ID:8662 EP_NO: N/A Repair Type: Non-Urgent Crossing Status: Found UCIP Comments: abandoned WS gates closed; handles broken; Structure needs to be properly abandoned. This crossing was listed in the USACE Periodic Inspection as ID# USACE_CESPK_HAM1_2010_a_0043 no issues reported. FIELD_STRUCT_DESC: Abandoned Sutter Butte Canal head gate structure, Six 6 by 8 foot concrete culvert 35.8 feet below the crown. Stems on gates are removed and gates are in a closed position. This entry matches the Drainage or Irrigation Structure referenced in O&M manual (Historic Station 47+00). (USACE O&M Manual, 1957) FS Date: 11/14/2012	39.454557 ° -121.640274 ° 39.454557 ° -121.640274 °	13 Y
----	------	------	--------------	-------------------------	----	---------	--	--	---------

View of concrete structure, Photo 1 of 2.

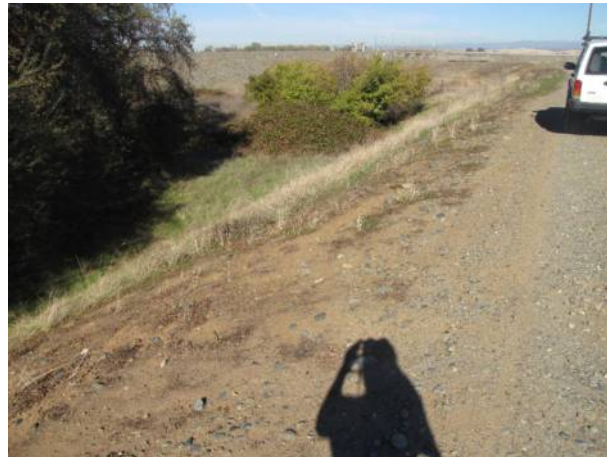
Levee Mile Report Line	16
Start Levee Mile	1.17
End Levee Mile	1.17
Location	Water Side
Category	Supplemental
Item	DWR UCIP Field Study

16	1.17	1.17	Supplemental	DWR UCIP Field Study	CR	M En	Inspector Comments: FS_ID:13238 EP_NO: N/A Repair Type: Non-Urgent Crossing Status: Indicator Found UCIP Comments: Abandoned structure: Structure is non-operational, slide gate is completely buried; top of slide gate barely visible from levee; 5/14/2013 Same as last inspection. FIELD_STRUCT_DESC: Abandoned 24-inch pipe through the levee 16.5 feet below the crown. Slide gate in CM riser on the waterward slope. No features of structure were found with the exception of slide gate frame. FS Date: 5/14/2013 12:48:22 PM	39.456287 ° -121.639530 ° 39.456287 ° -121.639530 °	18 Y
----	------	------	--------------	-------------------------	----	---------	---	--	---------

View of landward side looking upstream at crossing.

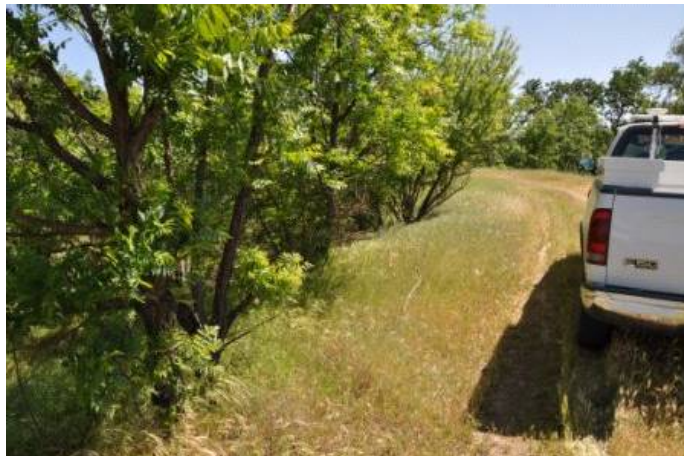
Levee Mile Report Line	19
Start Levee Mile	1.41
End Levee Mile	3.18
Location	Land Side
Category	Earthen Levee
Item	Trim / Thin Trees

L/S trees.

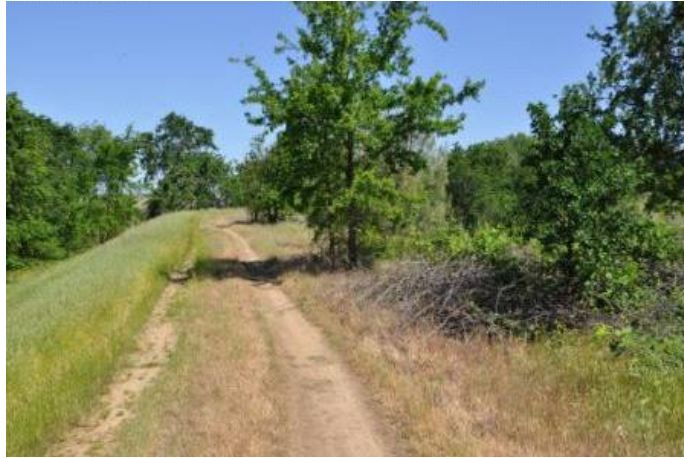
Levee Mile Report Line	20
Start Levee Mile	1.44
End Levee Mile	1.62
Location	Water Side
Category	Earthen Levee
Item	Trim / Thin Trees

W/S trees.

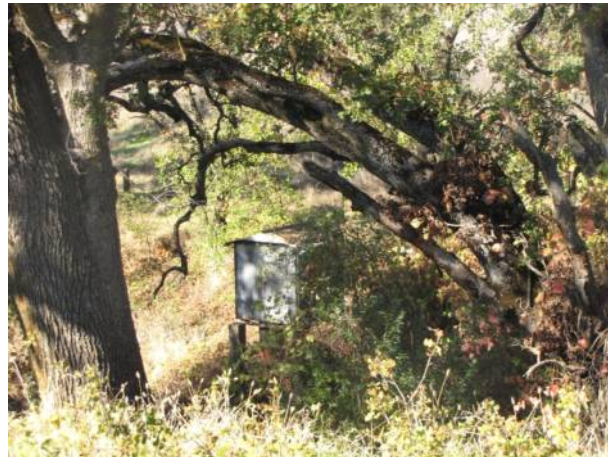
Levee Mile Report Line	24
Start Levee Mile	3.17
End Levee Mile	3.17
Location	Water Side
Category	Supplemental
Item	DWR UCIP Field Study

24	3.17	3.17	Supplemental	DWR UCIP Field Study	CR	M En	<p>Inspector Comments: FS_ID:7963 EP_NO: N/A Repair Type: Non-Urgent Crossing Status: Indicator Found UCIP Comments: Abandoned Structure: WS- reminence of gates and concrete standpipe; LS-reminence of concrete headwall and pump station. FIELD_STRUCT_DESC: Abandoned western canal head gate inlet structure. One (1) of 2 culverts, 8 by 8-foot concrete culverts through the levee 25.0 feet below the crown. Three slide gates on the waterward end. Concrete stairs on the waterward slope. Concrete headwall at both toes. This entry matches the Drainage or Irrigation Structure referenced in O&amp;M manual (Historic Station 170+00). (USACE O&amp;M Manual, 1957) FS Date: 11/14/2012</p>	39.470269 ° -121.609229 ° 39.470269 ° -121.609229 °	23 Y
----	------	------	--------------	-------------------------	----	---------	---	--	---------

Pump station located on landward side.
